Ron Morrison HOME INSPECTION

Report Summary

March 15, 2004

Re: Home inspection

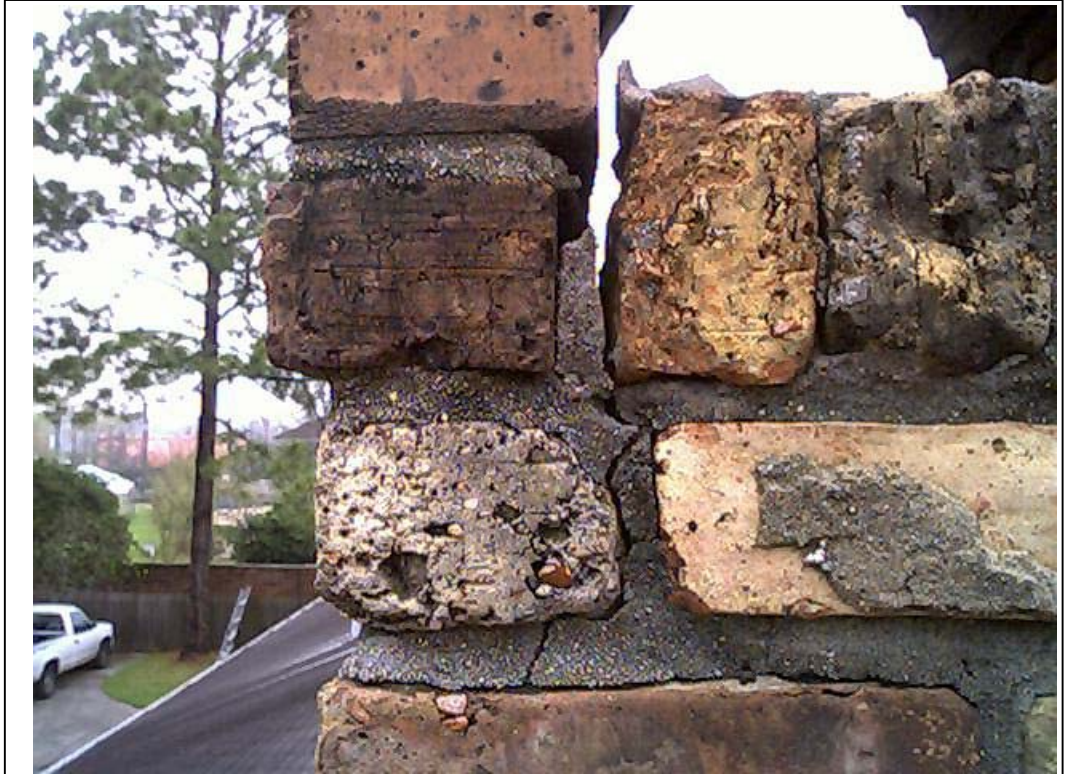
Mortar joints are deteriorated, Improper clearance to combustibles.
